May 10, 2005 Project No. 114-05035

# PHASE I ENVIRONMENTAL SITE ASSESSMENT APPROXIMATELY 153-ACRE VACANT PARCEL OF LAND NORTHWEST CORNER OF OTAY MESA AND HARVEST ROADS UNINCORPORATED SAN DIEGO COUNTY, CALIFORNIA

Project No. 114-05035 May 10, 2005

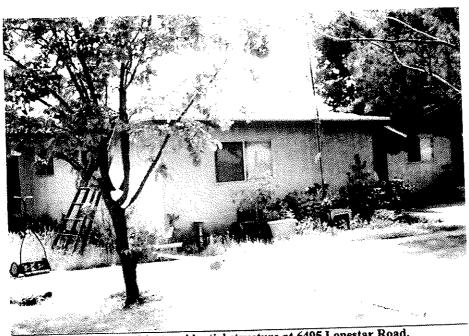
Photo 1: View of the subject residential structure at 6495 Lonestar Road.

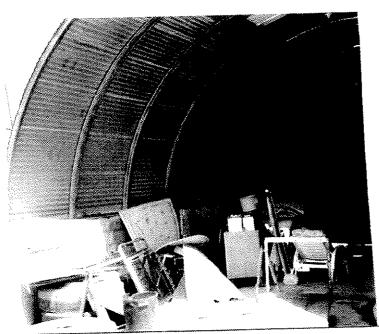
- Two approximately 1,200 square-foot metal storage buildings on concrete slab-on-grade foundations are located east of the single-family residential structure. At the time of Krazan's site reconnaissance the storage buildings contained household appliances, furniture, tires and miscellaneous household debris. A gravel parking lot adjoined the storage buildings to the north and west. Five tanker trucks were parked in the parking lot. Minor surface staining of the gravel parking lot surface was observed in the vicinity of the tanker trucks. At the time of Krazan's site reconnaissance it appeared that commercial vehicle maintenance activities were being conducted on-site.

Photo 2: View of the metal storage building interior.

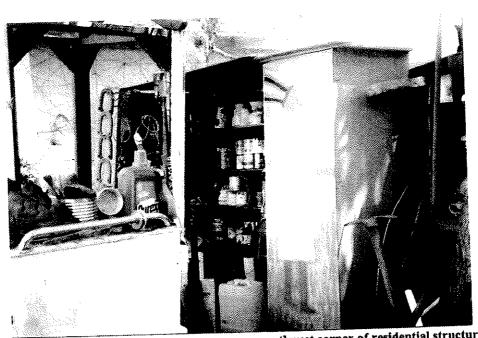
Photo 4: View of the paint storage area near northwest corner of residential structure.

Assessment (LSA) in the truck farm area and paint storage areas to determine if on-site shallow soils have been impacted by petroleum hydrocarbons and solvents.

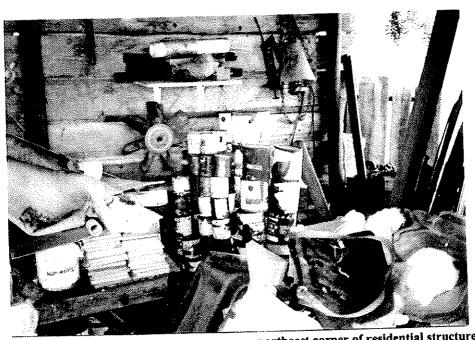
Photo 5: View of the paint storage area near northeast corner of residential structure.

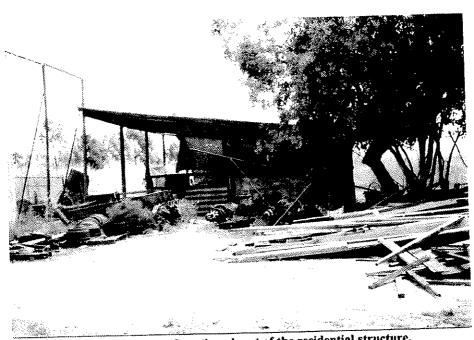
Photo 6: Storage yard located south and east of the residential structure.

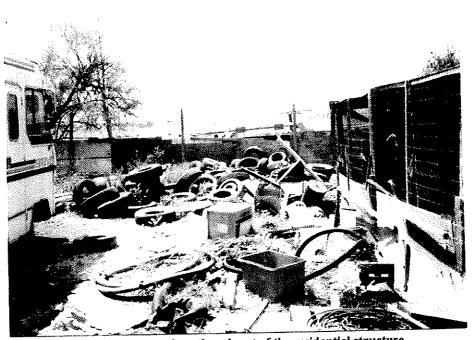
Photo 7: Storage yard located south and east of the residential structure.

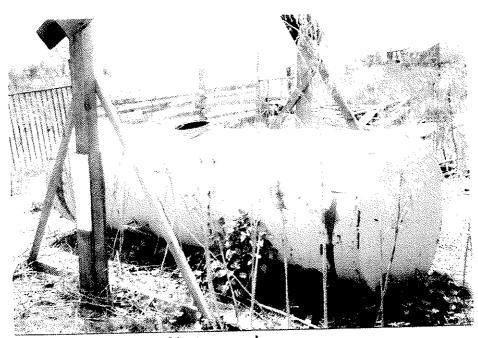
Photo 8: Empty AST located in storage yard.

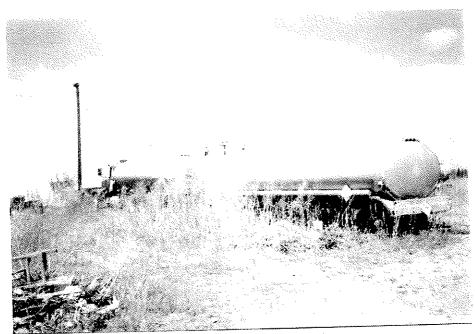
Photo 10: Tanker trucks located east of residential structure.

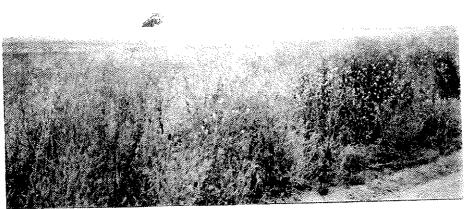
Photo 11: View of the subject site looking northeast.

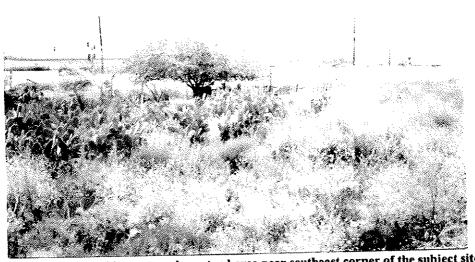
office furniture and miscellaneous household debris were observed in this area of the subject site formerly occupied by the Pinos fruit stand.

Photo 12: View of former produce stand area near southeast corner of the subject site.

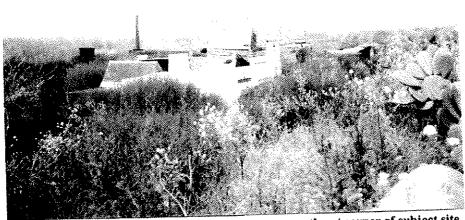
- Several large wooden produce containers were observed north of the asphalt parking area located
  on the south side of the subject site adjoining Otay Mesa Road to the north. A wooden fence,

Photo 13: View of wooden produce containers near southeast corner of subject site.

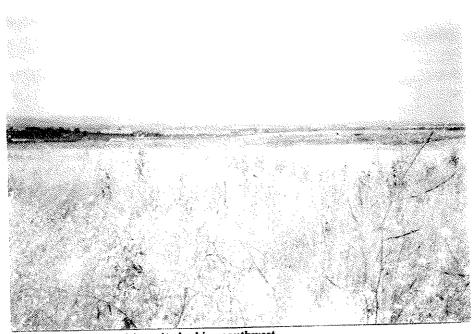
Photo 14: View of subject site looking southwest.

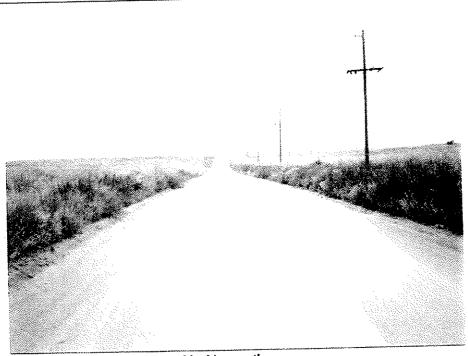
Photo 15: View of Harvest Road looking north.

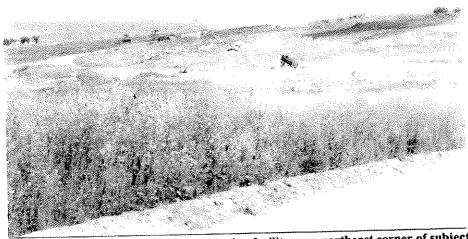
Photo 16: View of the adjoining composting facility near northeast corner of subject site.

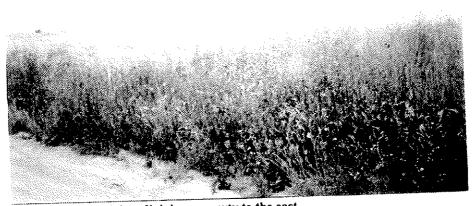
Photo 17: View of the adjoining property to the east.
